GNAV Toggle Arrangement

595-487-E
Date: 050305

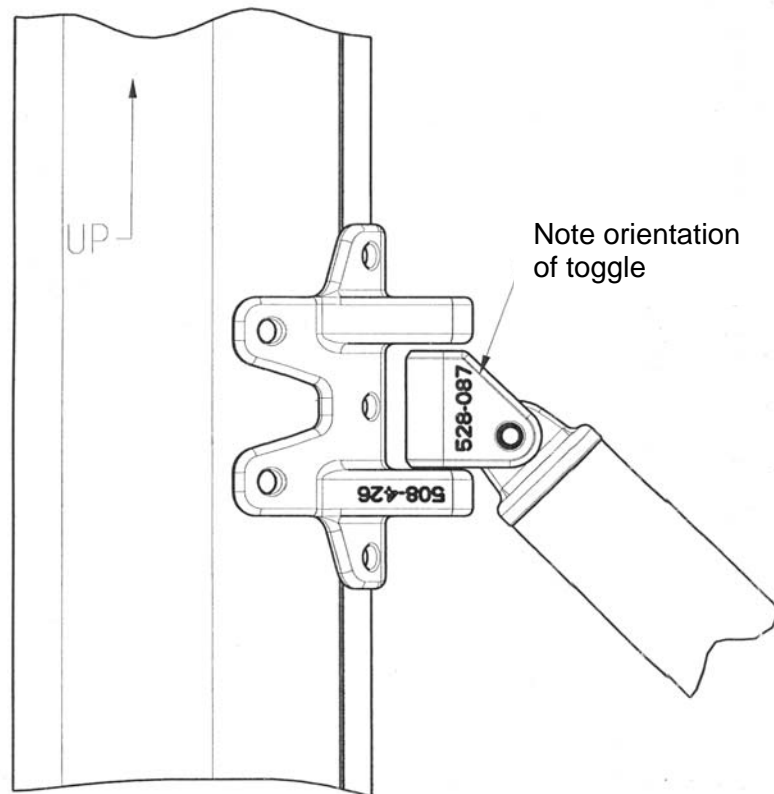
It is vital that the GNAV toggle is assembled as shown above.
Failure to do this will result in damage to the Strut Assembly
